Title: ENVIRONMENTAL QUALIFICATION TEST REPORT OF RAYCHEM WCSF-N NUCLEAR IN-LINE CABLE SPLICE ASSEMBLIES WYLE REPORT NO. 58442-1		Pages: 30 Enclosures:
Report Number: EDR-5032	Date: May 1, 1981	
Tested by: Wyle Laboratories	Signature: (see report)	Date: May 15, 1980
Prepared by: C. F. Albertalli	Signature: C F Albertalli	Date: May 1, 1981
Approved by: R. J. Scott for Product Management	Signature: R. J. Scott	Date: 1 May 81
Approved by: G. J. Clarke for Technical Operations	Signature: G. J. Clarke	Date: May 1 81

REPORT NO. 58442-1
OUR JOB NO. NDQ 58442
CONTRACT ---
YOUR P. O. NO. A01183

ENVIRONMENTAL QUALIFICATION TEST REPORT
OF
RAYCHEM WCSF-N NUCLEAR IN-LINE CABLE SPLICE ASSEMBLIES
FOR
RAYCHEM CORPORATION
MENLO PARK, CALIFORNIA

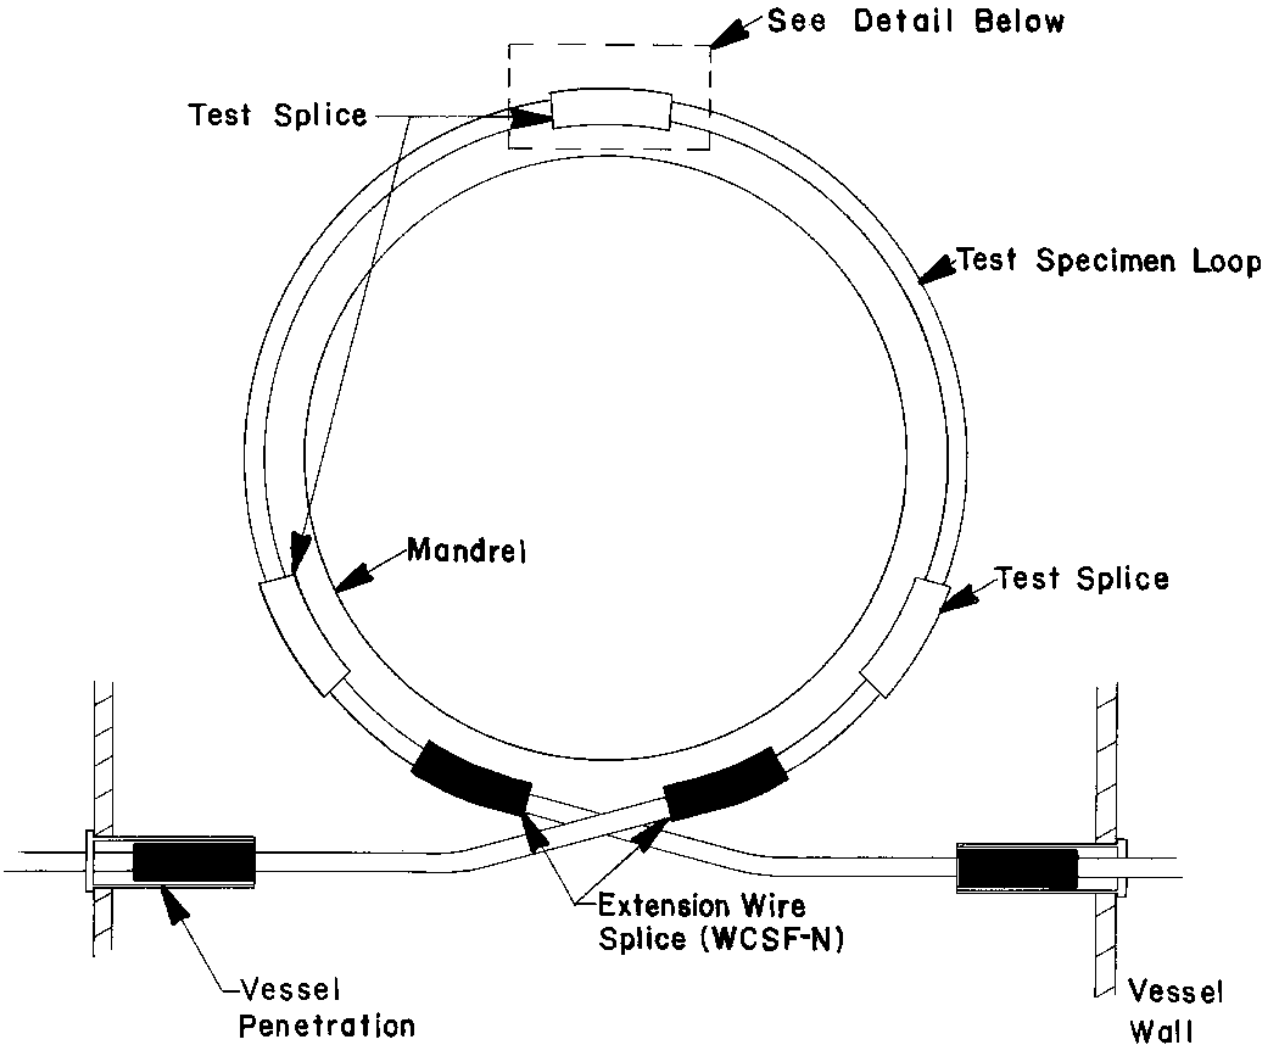
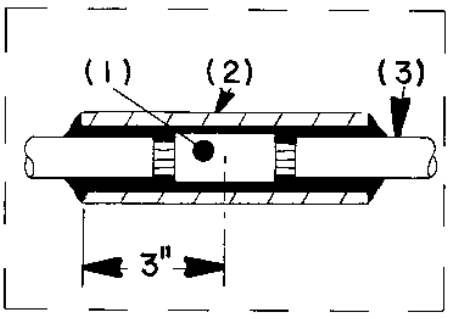
FIGURE 1. SAMPLE CONSTRUCTION

Each test specimen was comprised of three splices forming a test loop as shown in Figure 1. The materials used to make the splice systems are also listed. A total of six specimens, or eighteen splices, were used for the test program.

(1) Connector, Burndy YSV-10
(2) Raychem WCSF-N, Insulating Sleeve Size 115, 6Inch, Precoated With S-1119 Adhesive.
(3) Rockbestos Firewall III Insulated Wire, 1/C, 12 Awg. (.030 in. wall)

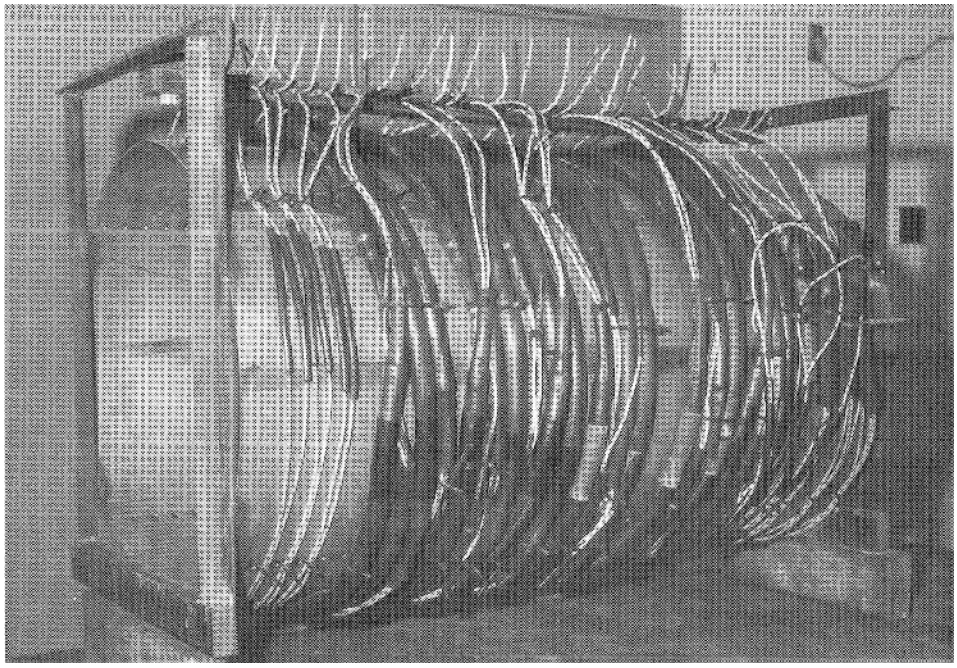
FIGURE 2. Mandrel and Samples

The mandrel, with the specimens in place, is shown in Figure 2.

(Specimens 1-1 through 1-6 are located at
the extreme left of the mandrel.)

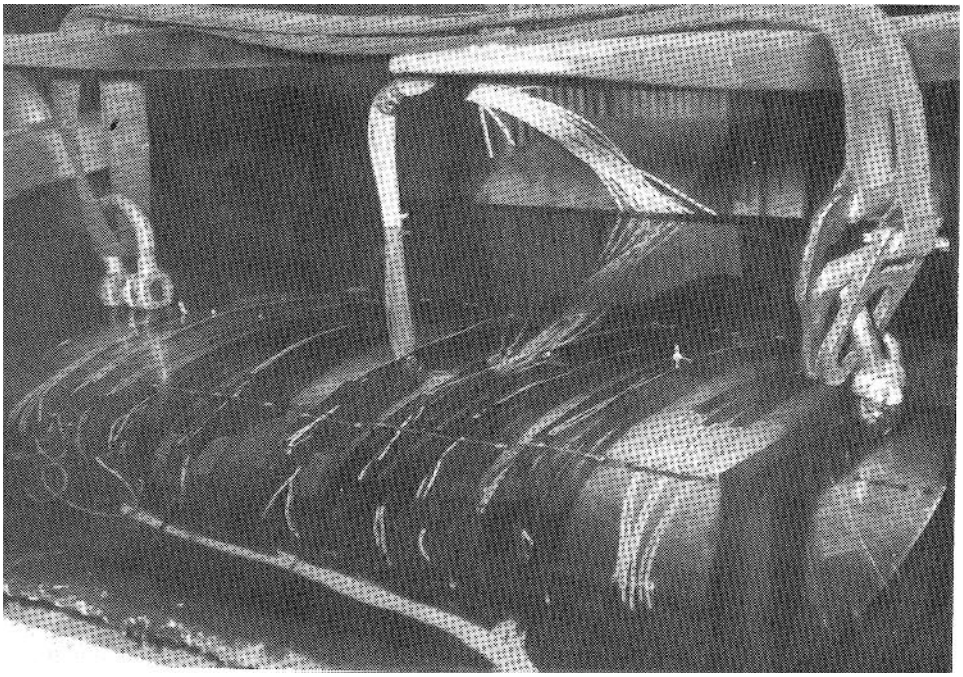
FIGURE 3. Mandrel and Samples Immersed in Water

The mandrel with the specimens in place was immersed in water and the insulation resistance measurements made. This was accomplished by splicing long extension leads to each end of the test loops. The splices between the specimens and the extension leads were also covered with WCSF-N heat shrinkable tubing. The mandrel immersed in water is shown in Figure 3.

All specimens again passed the five minute, 3.6kV a-c voltage withstand test. The insulation resistance values are given in Table 1 on page 13.

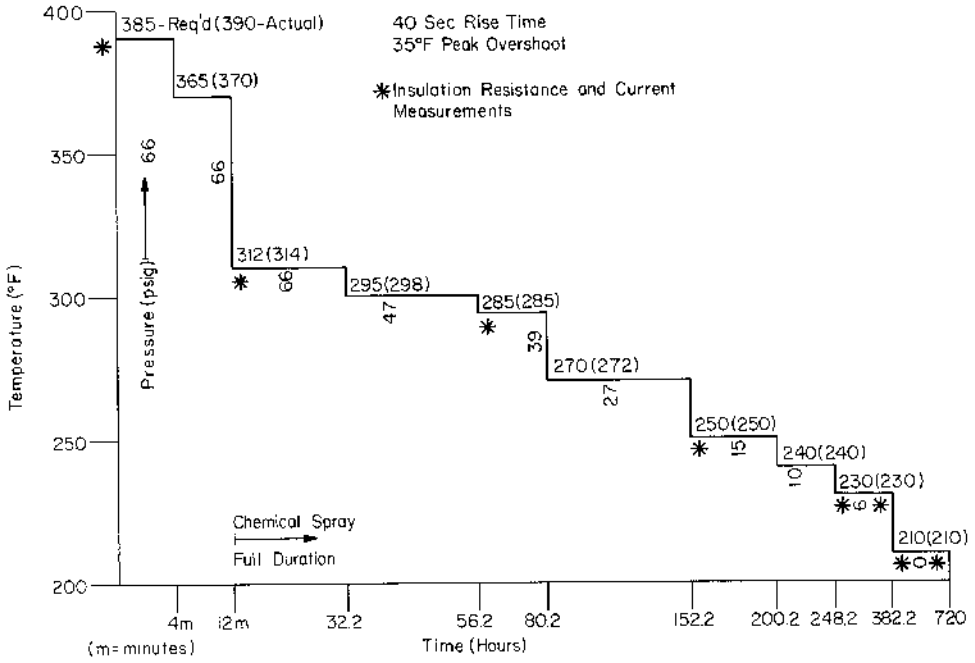
Figure 4. Temperature/Pressure Profile For Simulation of LOCA/MSLB Environment

The specimens on the mandrel were placed in a test chamber capable of exposing the specimens to the steam and chemical spray environment shown in Figure 4.

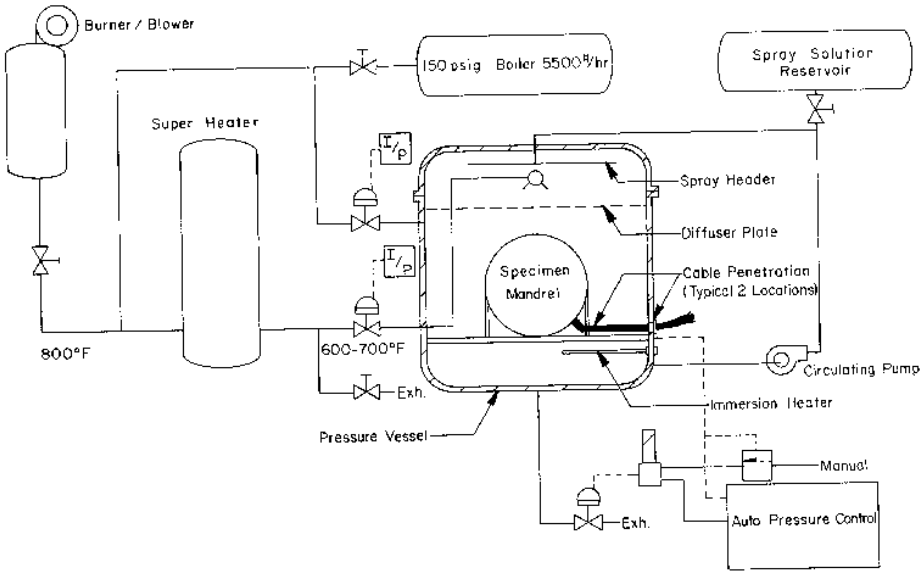
FIGURE 5. LOCA/MSLB PRESSURE VESSEL AND AUXILIARY EQUIPMENT

Fuses were installed in each specimen circuit so that during the exposure a breakdown in the insulation of one specimen would not affect the voltage applied to the others. Schematics of the test chamber and energizing circuit are given in Figures 5 and 6 respectively. All data acquisition instruments used in the test program are listed in Appendix 2.

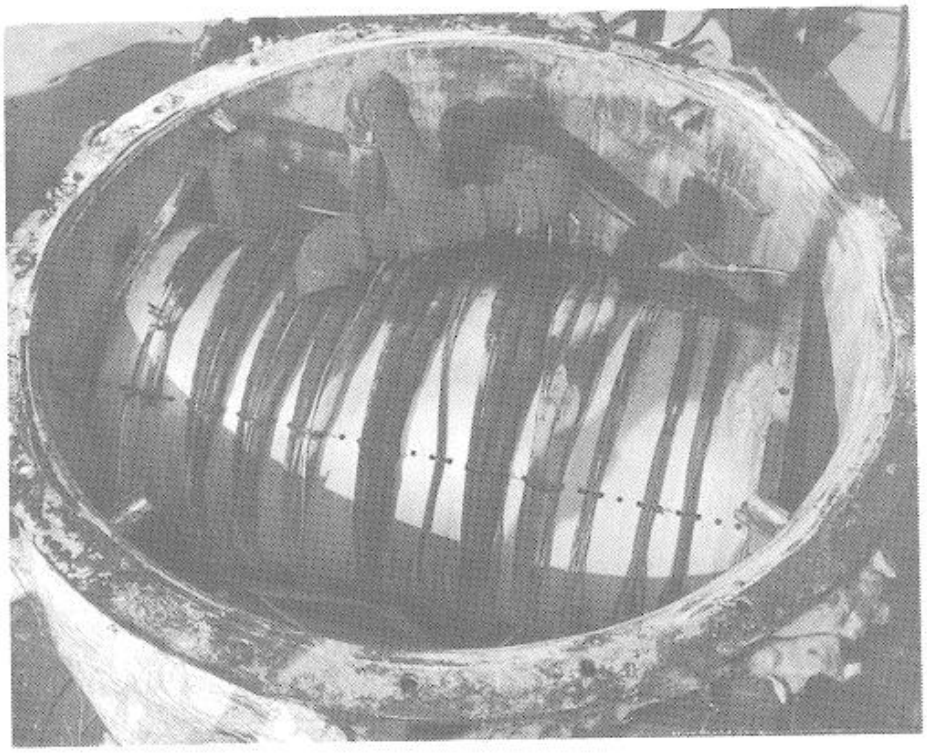
FIGURE 7. Test Chamber and Samples

The extension wires were cut inside the vessel so that the mandrel could be removed. This also allowed the penetrations to be inspected. It was found that some of the wires in the penetration had a low insulation resistance and would not pass the 3.6kV a-c voltage withstand test. The specimens associated with the penetration wires having a low insulation resistance were retested. The retest of specimens 1-3 and 1-4 showed high values of insulation resistance and both specimens passed the voltage withstand test. The low values previously measured on these specimens can therefore be attributed to the penetrations and not the specimens.

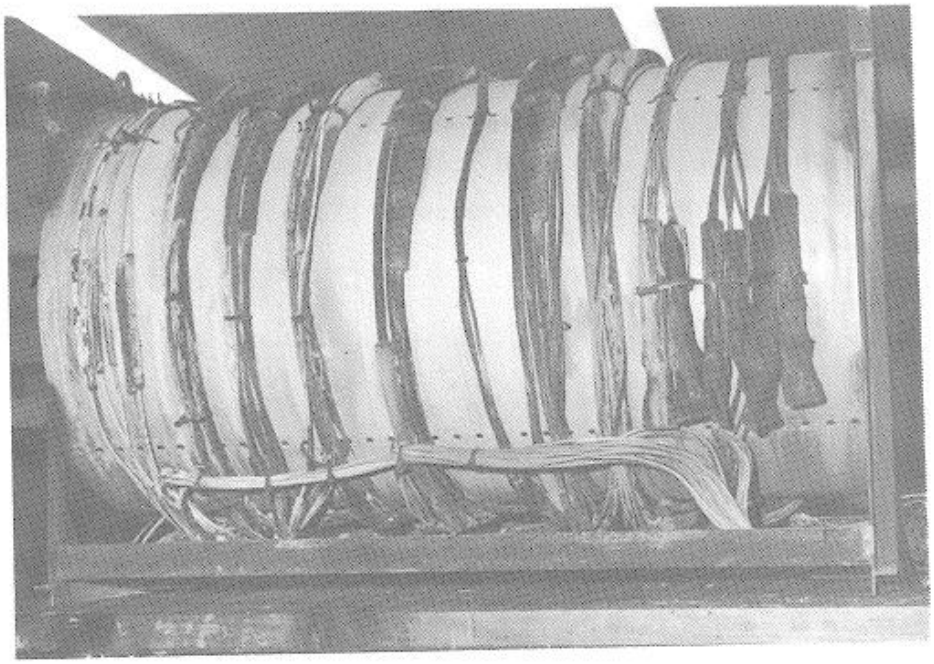
FIGURE 8. Mandrel After Removal from Vessel

Specimens 1-1 and 1-2 had cracked wire insulation near the splice sleeves and could not be immersed in water for the testing. In these cases, a metal foil ground plane was wrapped around the outside of the still wet splice sleeve and the insulation resistance and voltage withstand tests conducted. All six splices passed both tests after the sources of insulation failure elsewhere in the test loops were isolated.

Visual examination of the splice sleeves showed surface degradation and some crazing. This was most apparent in specimens 1-5 and 1-6.
